Upstream  
East Gate  
March 2001

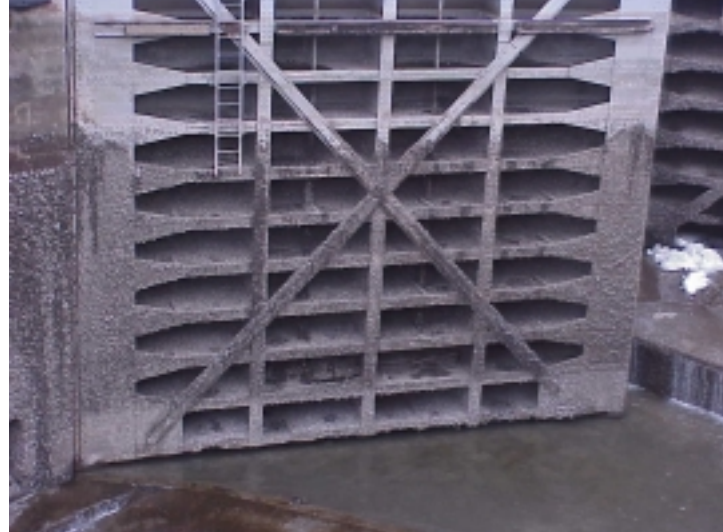
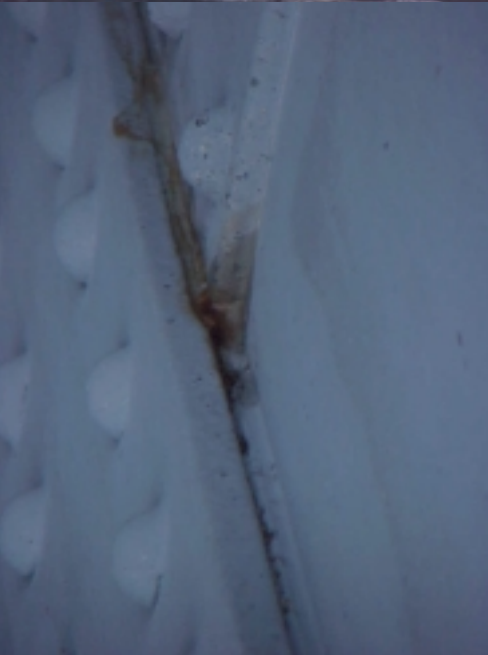
Atmospheric  
area has rust  
stains bleeding  
from joints.

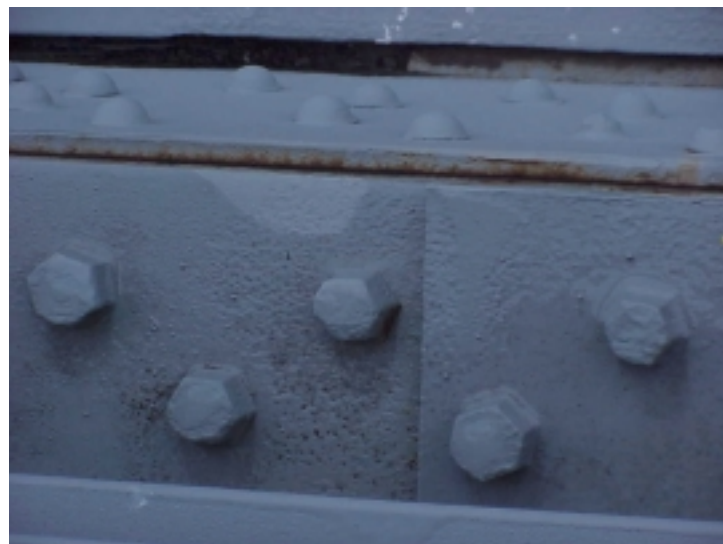
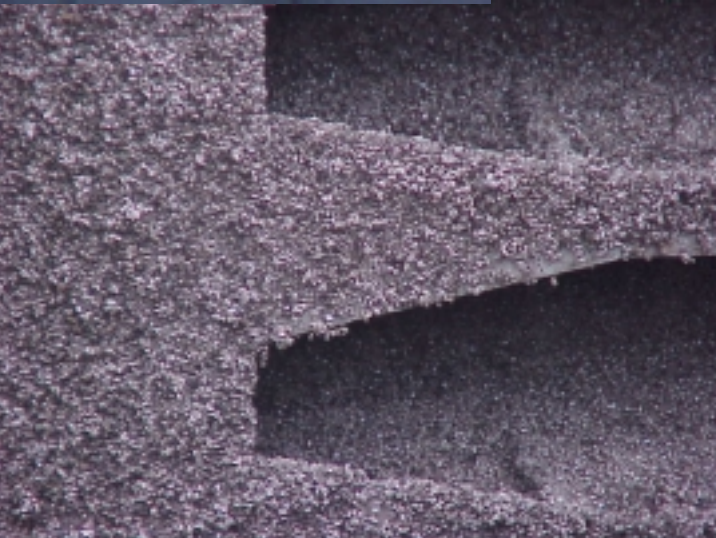
Zebra mussels on lower portion of gate  
may hide corrosion.

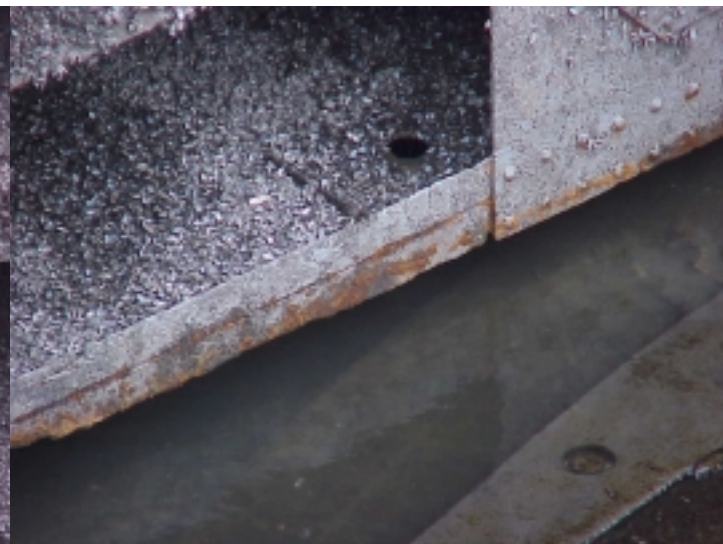
Coating on bottom flange of gates  
is commonly damaged.
